**ARBORIST REPORT
FOR
Schoen Property
Kirkland, WA**

September 20th, 2013

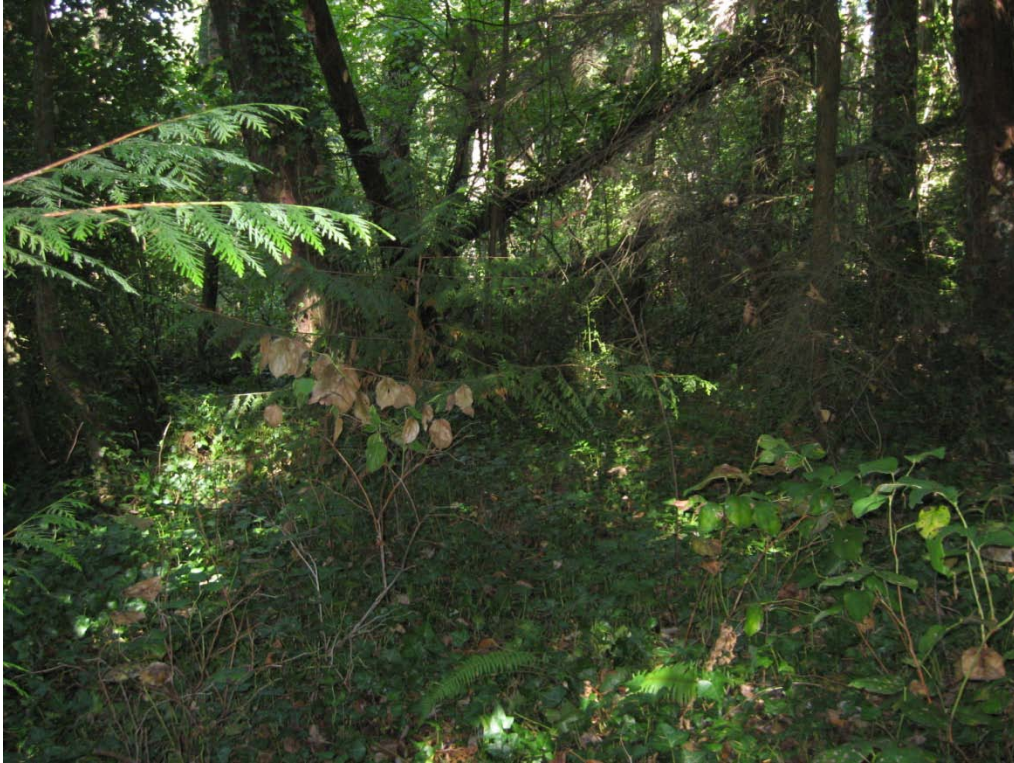
Site Photo – NE Portion of site

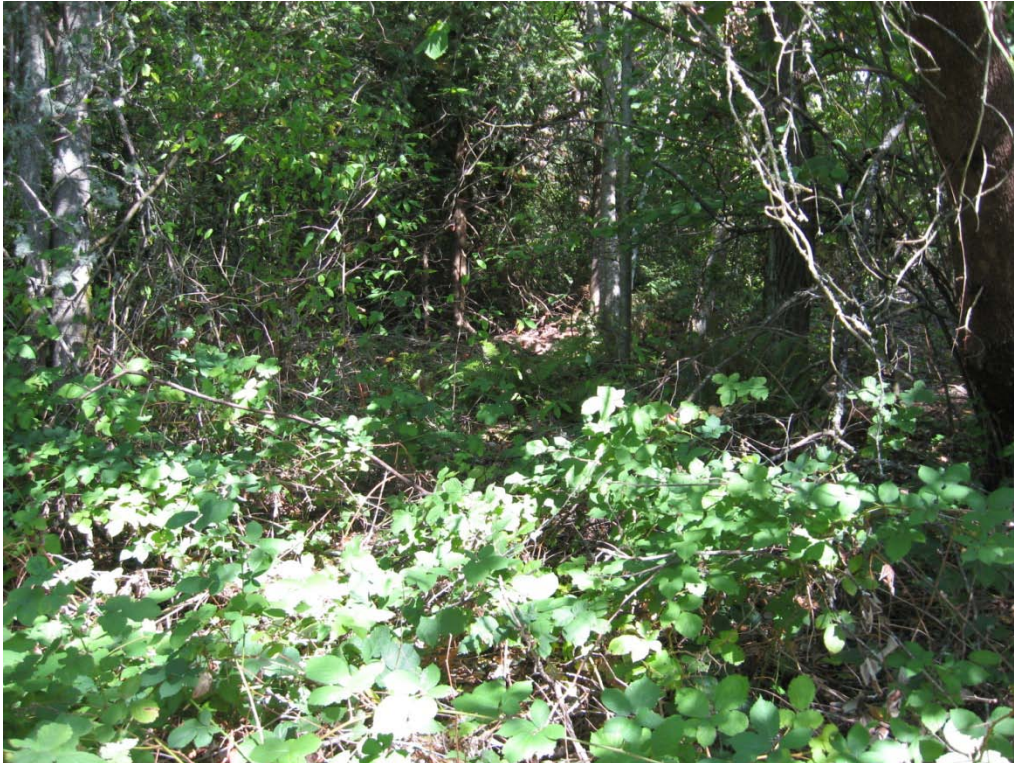
The southern middle portion of the site has a significant infestation of non-native Himalayan blackberry. Here the blackberry is inhibiting the growth of any trees or native vegetation.

Southern portion of site

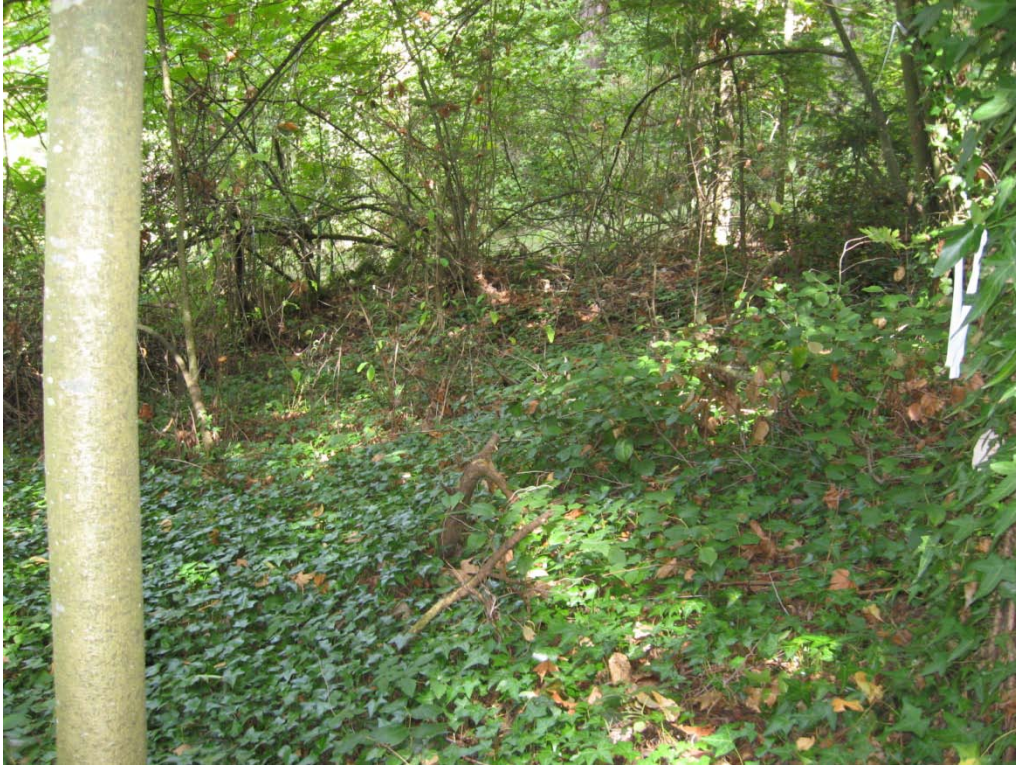
West portion

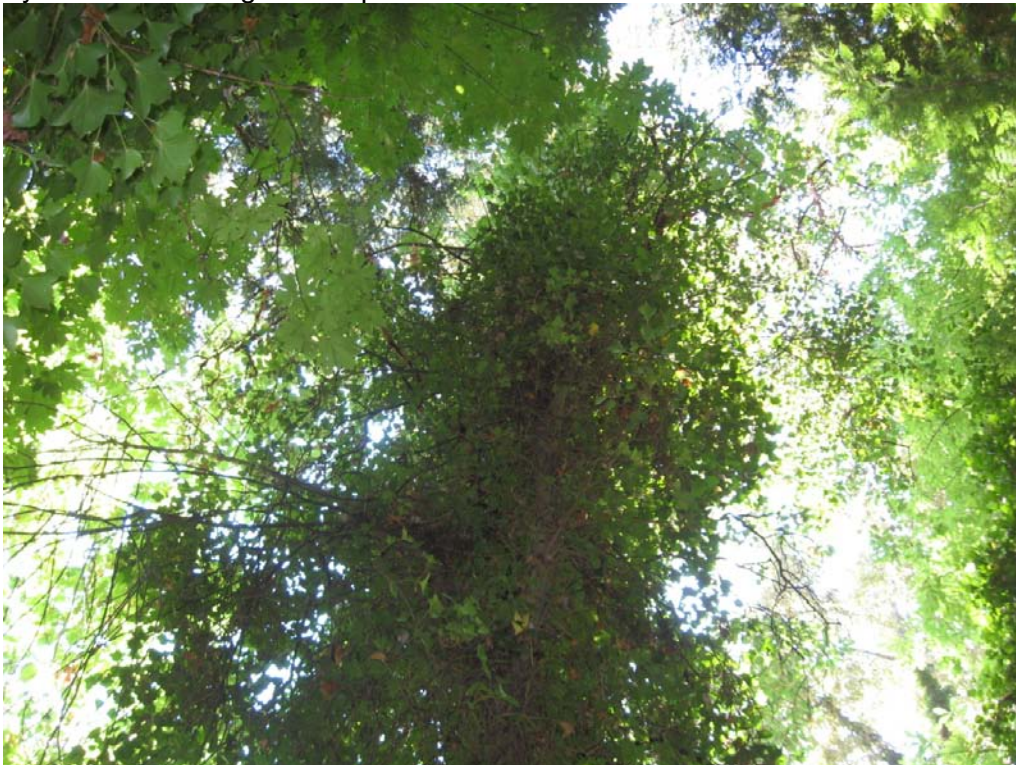
The density of English ivy is a significant concern on the property. It is found in all portions of the site and has encroached upon more than two-thirds of the subject trees. The ivy has limited the growth of native groundcovers. Native groundcovers of salal, swordfern and Oregon grape are found scattered across the property. Native shrubs are found across the property and are primarily comprised of beaked hazelnut and Indian plum; with minor components of oceanspray, baldhip rose and red huckleberry. Shrub density is variable and shrubs are often found in small groupings.

Ivy infestation in big leaf maple

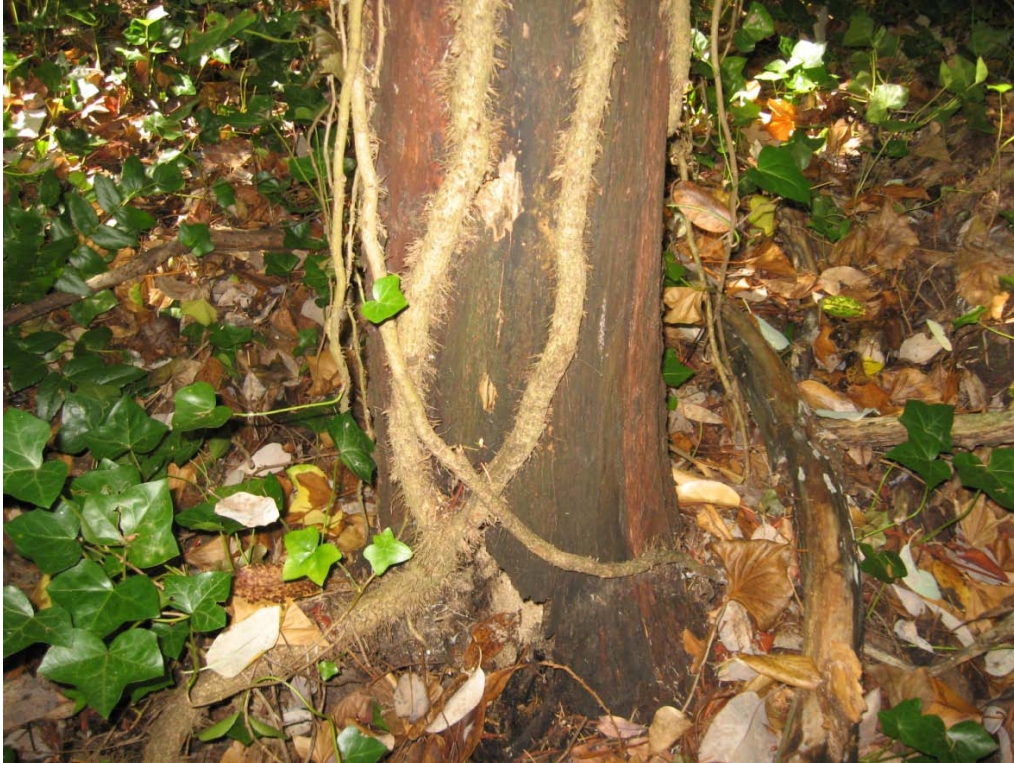
The Pacific madrone trees overall are in fairly good condition. These have developed typical crown forms which in most cases extend excessively in one direction to fill a void in the canopy. Five dead madrone trees were identified in the northeast corner of the property. These were primarily smaller diameter trees that likely suffered from suppression by larger adjacent trees. Some of the madrones have significant branch dieback. *Nattrassia* cankers were observed on the lower trunks of a few trees in that northeast portion of the property.

Nattrassia canker on Pacific madrone #5151

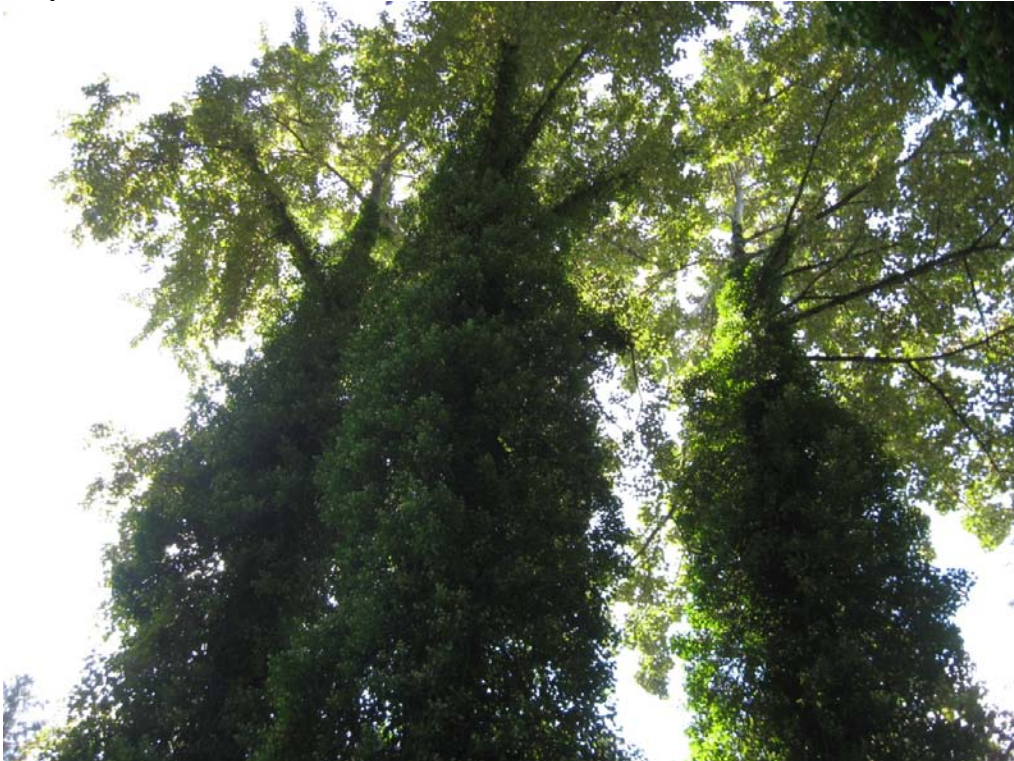
Tree #5167 is a 24" cottonwood on the south perimeter. The main stem is broken at approximately 55' above ground. The tree leans heavily to the southwest and is covered in ivy. Failure risk is high. The other three over-mature cottonwoods around #5167 are all 'borderline' viable. All have extreme ivy infestations.

Subject cottonwood trees #5165, #5166, #5167 and #5168

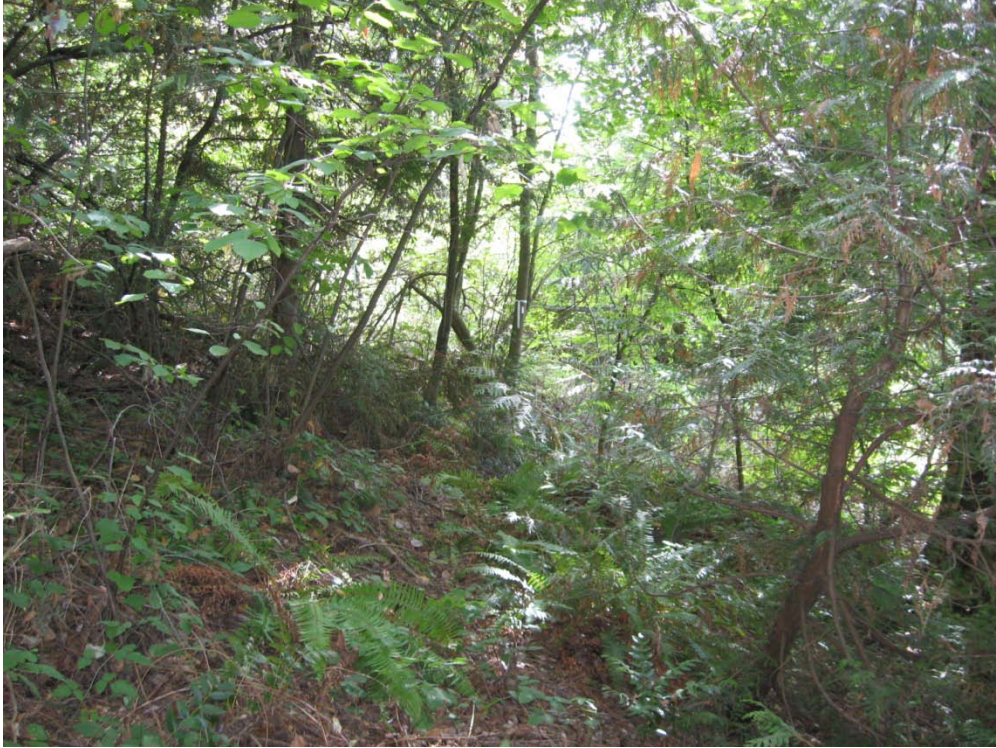
Trees #5003, #5004 and #5005 are young to semi-mature Oregon ash trees at the front of the property. All have developed very poor trunk taper and crown form due to intense competition with surrounding vegetation. All are highly susceptible to breakage from wind, ice or snow events.

Subject Trees #5003, #5004 and #5005 at front of property

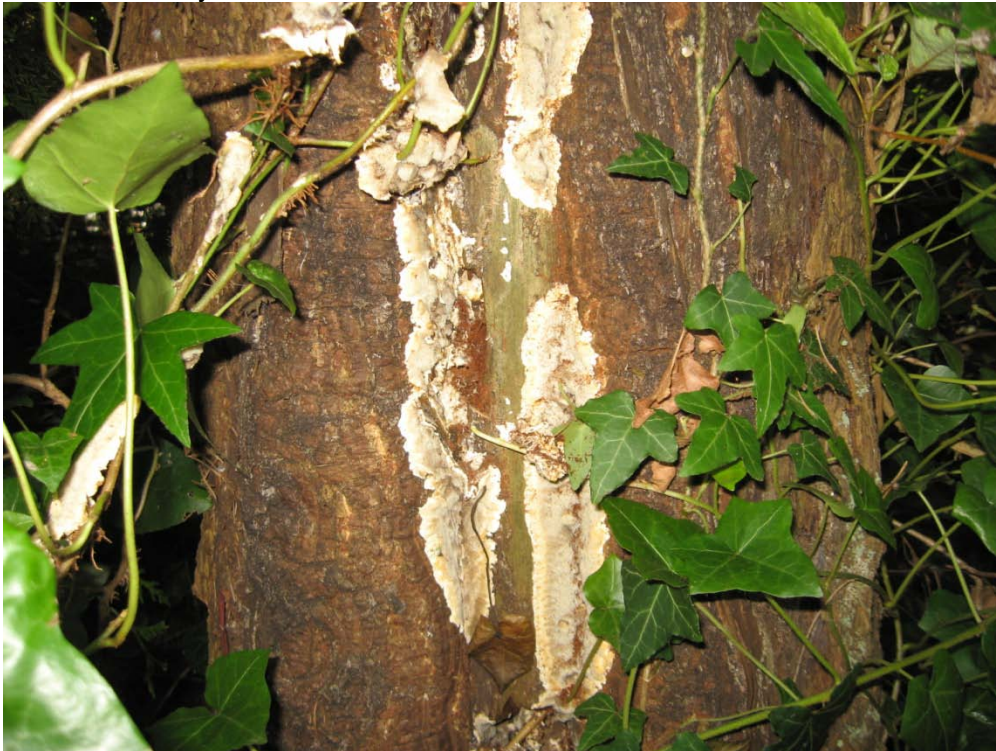
Tree #5125 in the utility easement is in poor condition. Extensive rot was observed on the lower trunk associated with a very old injury to the trunk. The subject leans to the south. The risk of trunk failure is high.

Extensive decay in lower trunk of #5125
